FIVE-YEAR REVIEW
UMETCO MINERALS CORPORATION
URAVAN SUPERFUND SITE
URAVAN, COLORADO

U.S. Environmental Protection Agency, Region VIII
999 18th Street
Denver, Colorado 80202

Frontier Environmental Services, Inc.
5171 Ward Road, Unit 1
Wheat Ridge, Colorado 80033

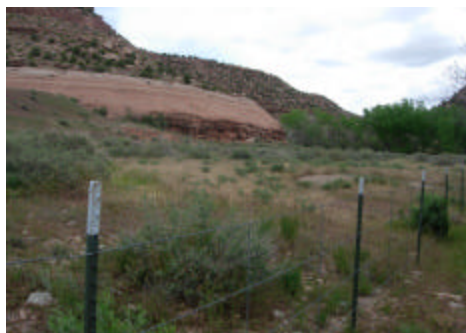
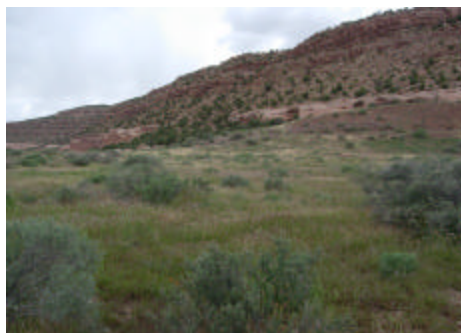
The on-site visit of May 11, 2005 found Atkinson Creek Disposal Area to be visually restored and well vegetated as compared to the surrounding areas not included in the Atkinson Creek Disposal Area. Crystals, discoloration, or other signs of contamination were not observed in this area. Visible signs of severe erosion were also not observed. Vegetation had re-established itself and visually appeared to be very healthy. The site is equipped with a well maintained fence, which aids in keeping grazing animals off the site.

Reclaimed and vegetated Atkinson Creek Disposal Area, May 2005

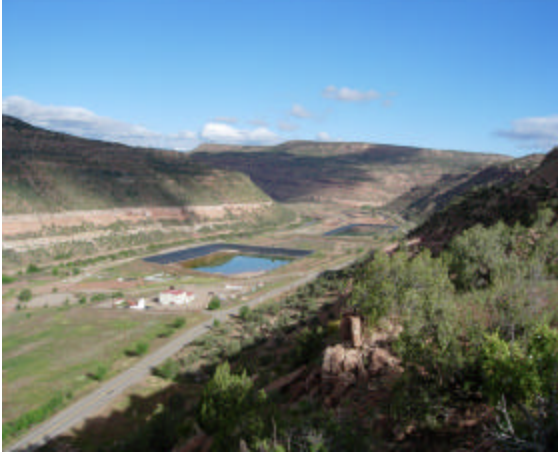
During the site visit on May 11, 2005, the three remaining lined Club Ranch Evaporation Ponds: CRP #1; CRP #4; and CRP #8 were inspected. CRP #1 and CRP #8 visually appeared to be in fair condition. While no visible defects were observed during this inspection, weathering and operational wear was apparent. However, a detailed inspection conducted by Umetco personnel on May 12, 2005 identified two liner failures

Club Ranch Ponds CRP #8, CRP#1
and CRP#4

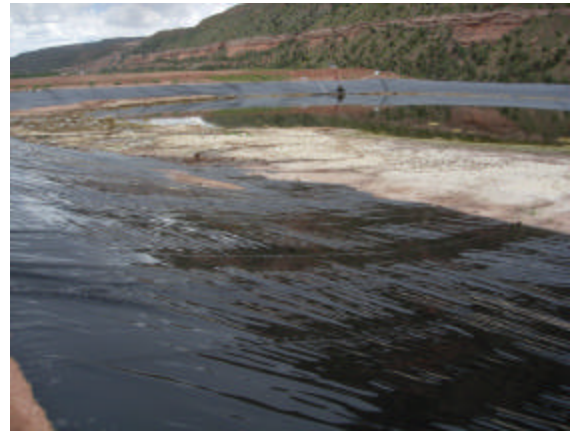
The inspection of May 11, 2005 indicated that Club Ranch Pond CRP #4 had suffered significant liner failure due to excessive liner tension forces imposed during a period in which the pond was left empty and allowed to go through a series of temperature extremes. The temperature extremes created a condition that allowed CRP #4 liner to "trampoline" or otherwise become stretched beyond the support of its sub-grade. When the stressed CRP #4 was filled during the winter/spring period of 2004/2005, the stress liner failed in at least eight locations. Liner failure occurred in parent material, fusion welds and extruded welds. The majority of the liner failures were on the crest or outside of CRP #4 containment bowl. Two of the eight liner failures were within CRP #4 containment bowl, but were located approximately two-feet above pond water line. Inspection of CRP#4 leak detection sump indicated presence of liquids, but not in quantities or volumes that would trigger Liner Failure Contingency Plan. Club Ranch Evaporation Pond CRP #4 has been taken out of service, drained and scheduled for excavation and removal with disposal of its liner and any contaminated materials to an approved on-site Club Mesa Repository (B-Plant Repository). Reference Umetco UraVan Club Ranch Ponds Synthetic Liner Inspection Report, dated May 20, 2005.

CRP #4 Interior Liner Trampoline Effect

It is recommended that the Club Ranch Pond CRP #4 be removed from service immediately (This action was implemented as of May 20, 2005) and be excavated and removed during the 2005 remediation season with disposal in an on-site approved repository (B-Plant Repository). Club Ranch Ponds CRP #1 and CRP #8 should be repaired at the earliest time achievable. Club Ranch Ponds CRP #1 and CRP #8 should be inspected daily for liner deterioration and failure and their leak detection systems inspected and evaluated on a weekly basis until removed from operation.

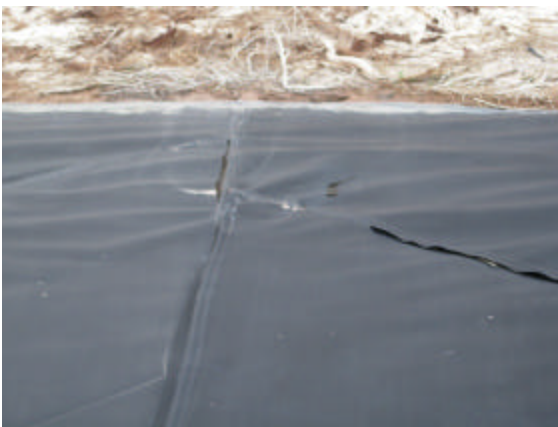
Club Ranch Pond CRP #4
Interior Liner Failure

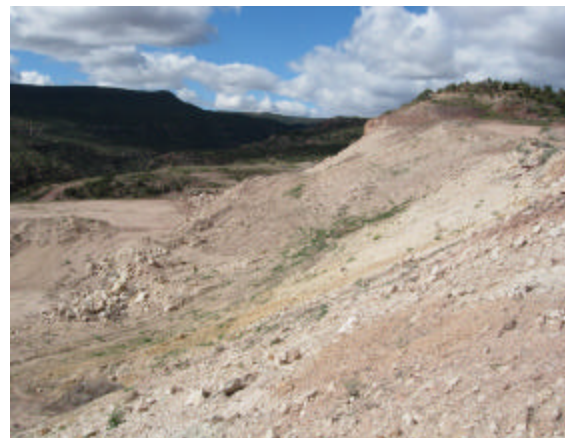
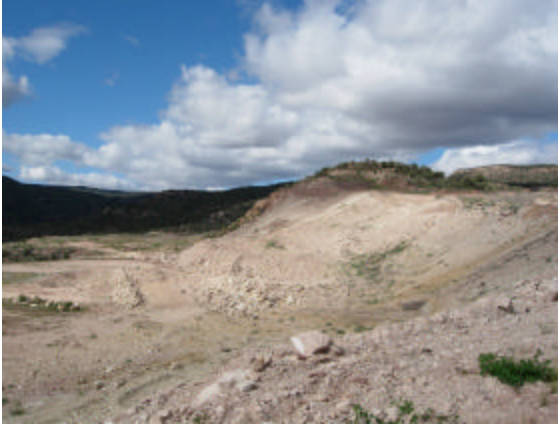
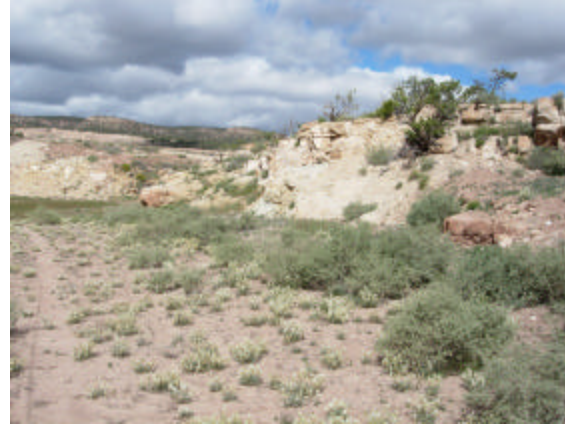
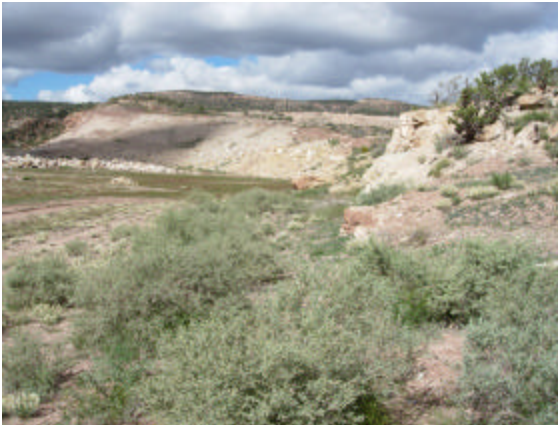
The joint separation on Tailings Pile 3 noted in the 1999/2000 Five-Year Review has been mitigated. Joint separation was due to overlooking and adjoining bedrock displacement and not movement of the tailings pile. Inspection of Tailings Pile 3 indicated a stable and well drained cap system.

Photo 1 of 4 of Tailings Pile 3 Repair
of Suspected Joint Separation

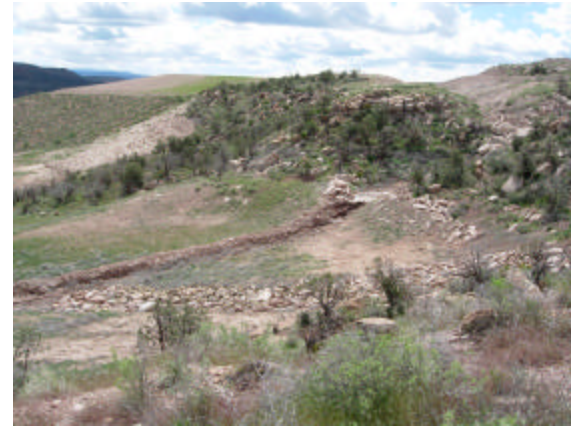
A storm water erosion feature of some significance was noted coming off the northeast face of Tailings Piles 1 & 2 adjoining the Club Mesa Area. This erosion feature should be inspected and repaired as needed.

Club Mesa Storm Water Run-Off
Erosion/Washout Feature

Club Mesa Tailings Piles 1 and 2 and Club Mesa Area north facing storm water erosion features require inspection, maintenance and repair.

Site visit observations indicate the need to inspect and repair erosion features created by storm water run-off from the Club Mesa Areas and Club Mesa Repositories. This would include those areas that are now part of site drainage patterns because of

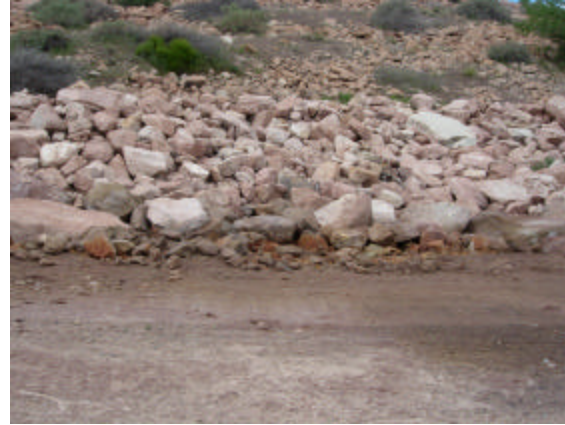
Seeps from Tailings Piles 1, 2 and 3 noted in the 1999/2000 Five-Year Review have been mitigated to an extent. However, as observed during the May 2005 site visit, collection of possible tailings piles seeps with meteoric water was present in Sump #1. Prior to the de-commissioning of the scheduled Sump #1 in FY2005; Umetco needs to confirm mitigation methods and performance on measures implemented to stop seeps from the Club Mesa Tailings Piles have been achieved.

Example of Club Mesa Tailings
Piles 1 &2 Seepage Staining

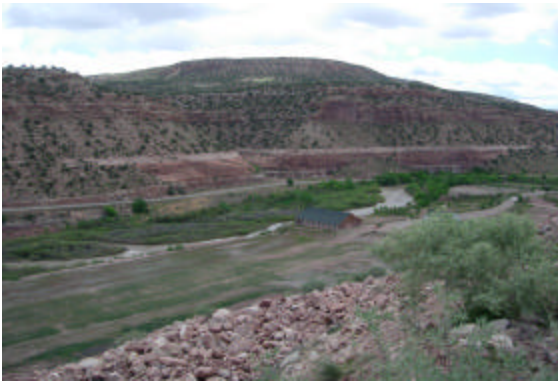
The site visit of May 11, 2005 visually found the Town of Uravan and the Adjacent Areas fully remediated, except for the portion of Colorado Highway 141 and the Windblown Areas. No visible signs of remaining contamination, e.g. buildings; drums; equipment; discolored soil; tailings; etc. were observed in these areas during the site visit. Grading and site reclamation and revegetation of the Town of Uravan and Adjacent Areas appeared to have been completed, and healthy-looking vegetation has been reestablished in these areas.

In the distance, Un-remediated Colorado Highway 141
